**Task Order 2  
Enhanced Preliminary Assessment**

**BENNETT ARMY  
NATIONAL GUARD FACILITY  
DENVER, COLORADO**

January 1990

**Roy F. Weston, Inc.  
West Chester,  
Pennsylvania 19380**

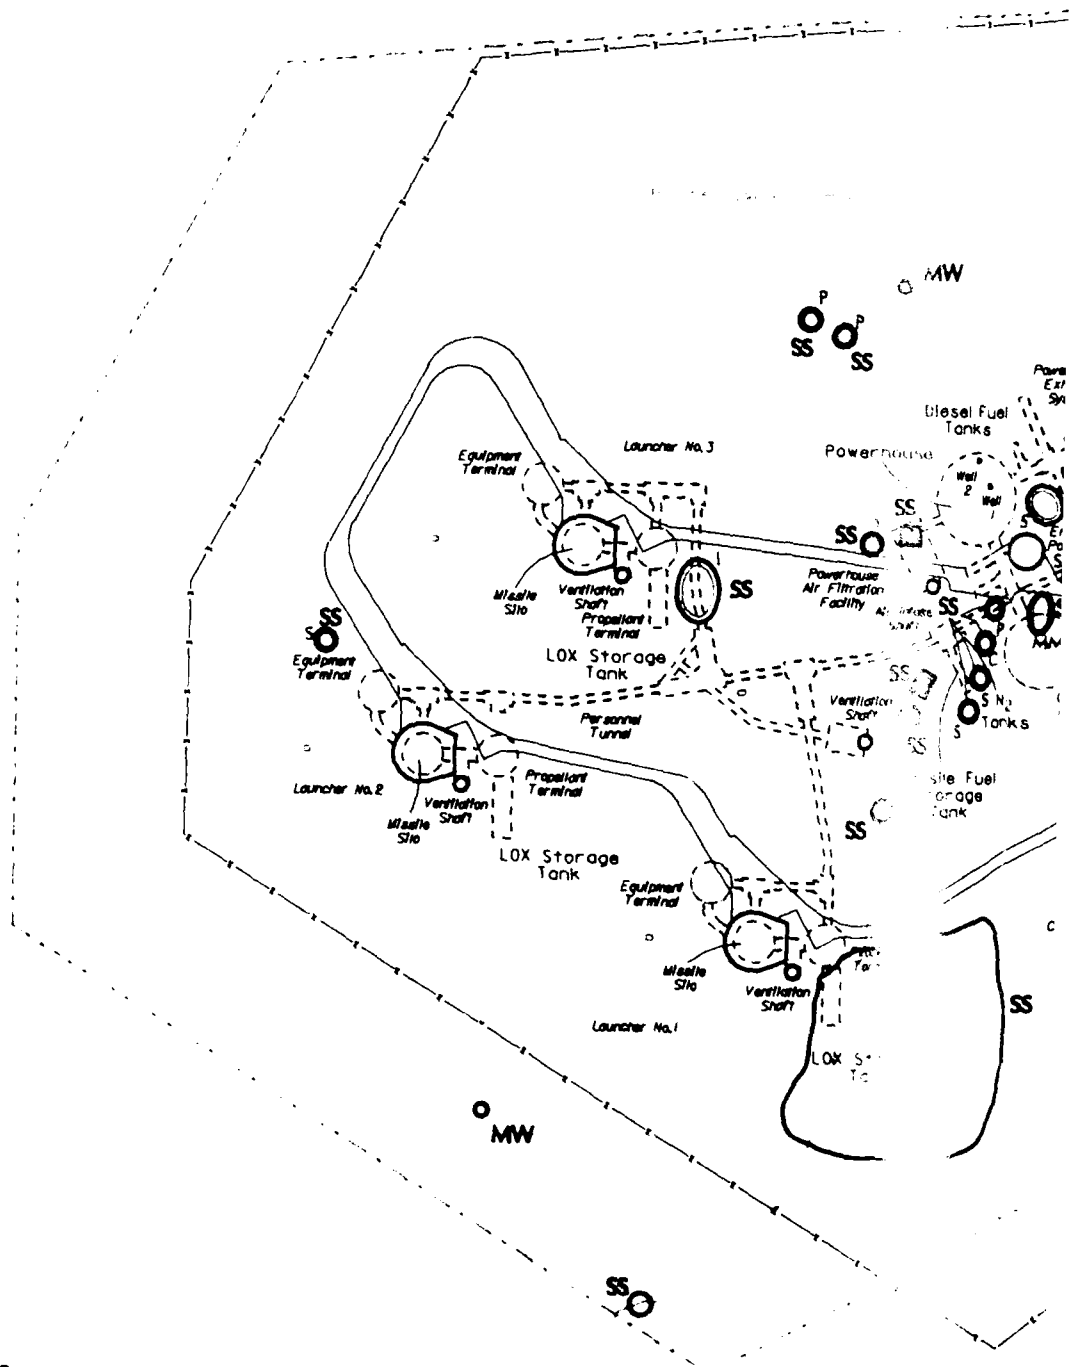
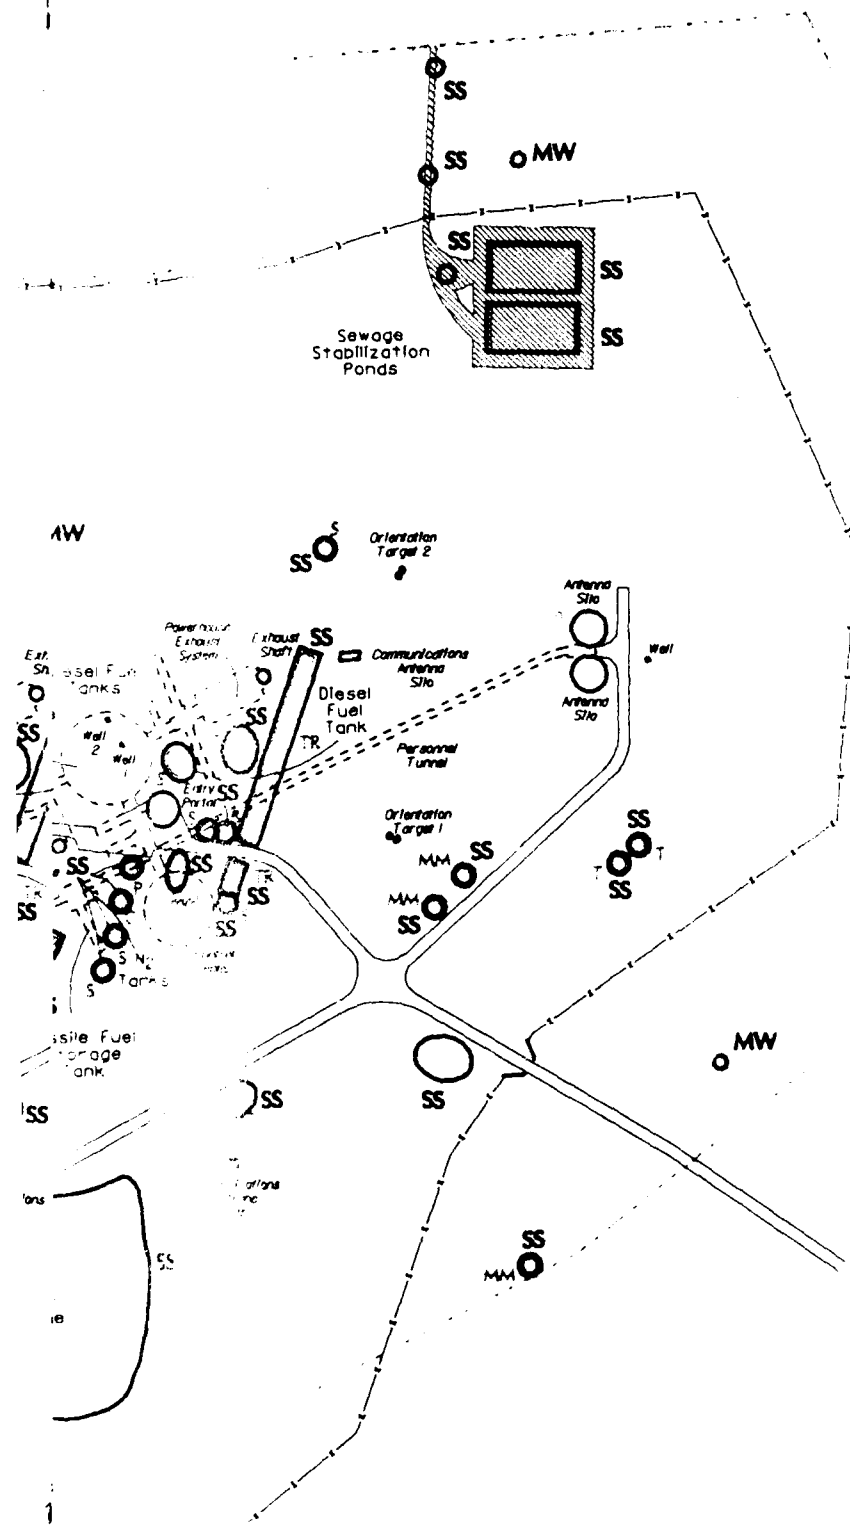
Figure ES-1  
Property Information  
Composite

No environmental conditions were observed on the property that appear to present an immediate, substantial threat to human health or the environment. However, the ESOs discussed in this report have the potential to affect human health and the environment. The recommendations concerning each ESO follow and are summarized in Table ES-1. Recommended sampling locations are shown in Figure ES-1.

It is recommended that four ground monitoring wells be installed. These wells should be distributed near the perimeter of the facility. Samples from these wells should be analyzed initially for volatile organic compounds (VOCs), base neutral acid extractables (BNAs) Resource Conservation and Recovery Act (RCRA) metals: arsenic, barium, cadmium, chromium, lead, mercury, selenium, silver, PCBs, and total petroleum hydrocarbons (TPHs). The integrity of existing wells should also be checked. These wells should be sampled and analyzed for VOCs, BNAs, RCRA Metals, PCBs, and TPHs to determine if any cross contamination has occurred.

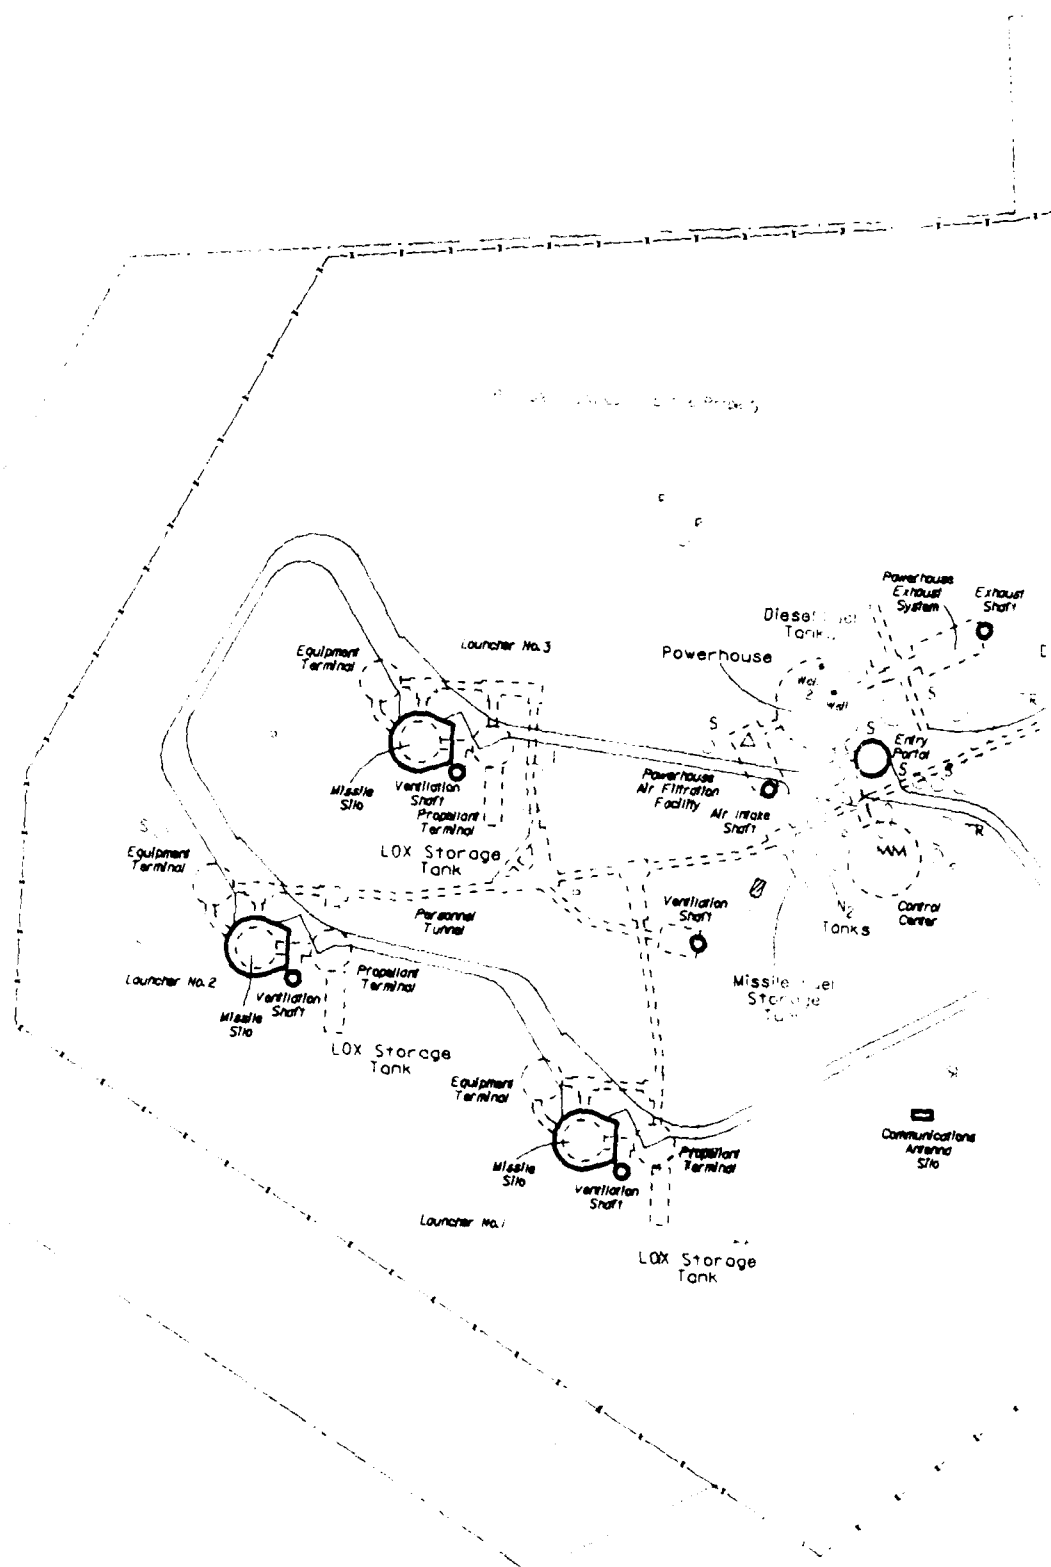
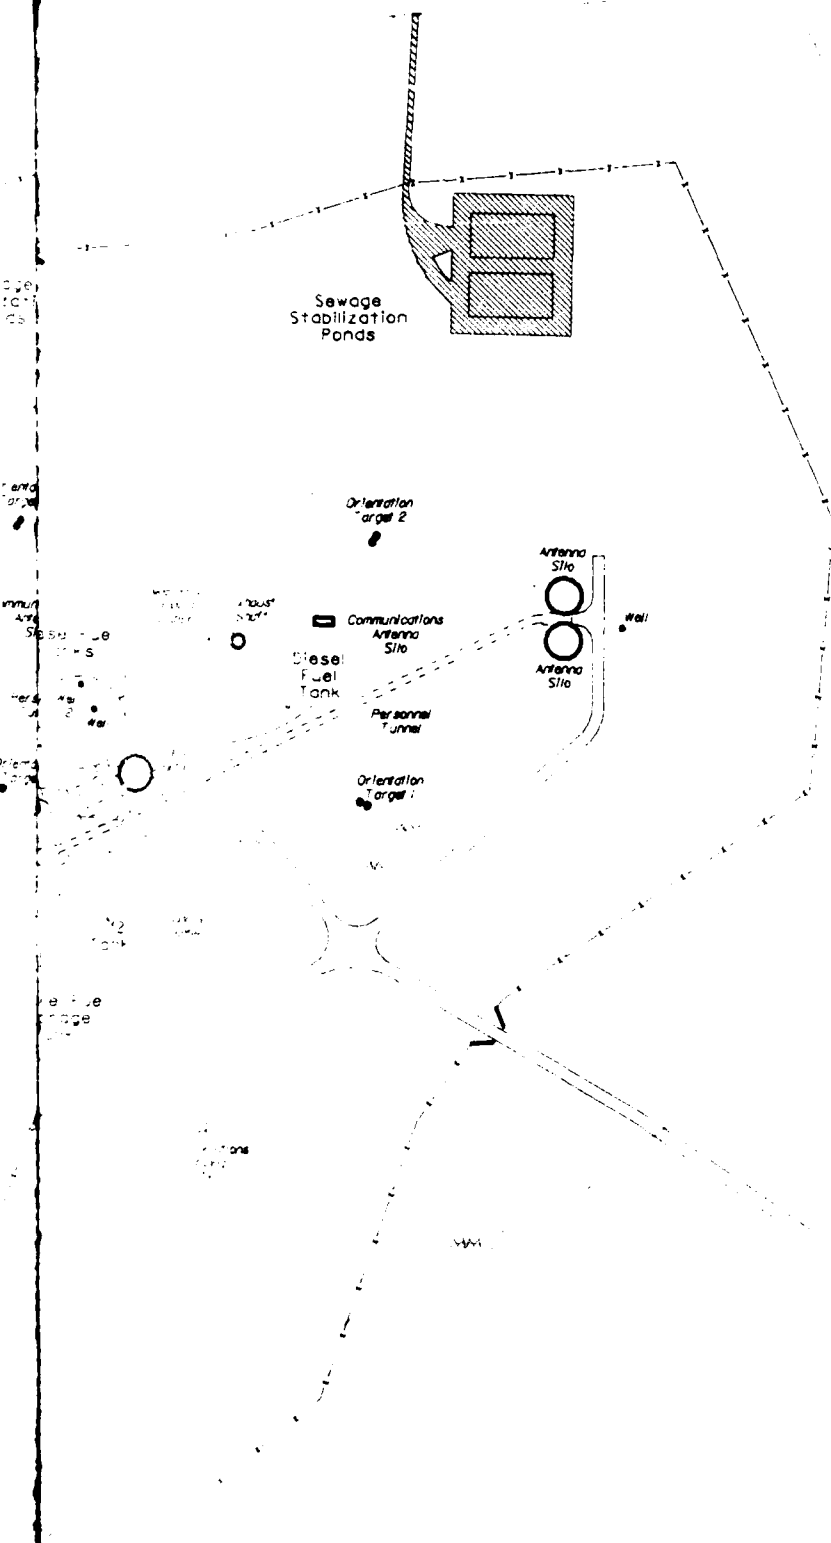
Figure 3-1  
Environmentally Significant  
Operations

The objective of this section is to document areas where hazardous materials may have been managed and to identify known potential releases of these materials into the environment and their likely migration pathways. The locations of all identified ESOs are shown in Figure 3-1.

The Environmental Photographic Interpretation Center (EPIC) report (Figure 3-1) identified 23 areas where wastes could have been disposed. From 1963 to 1985, mounded material, ground stains, containers, trenches, tanks, and pits were detected at several locations throughout the facility [R-5]. These areas ranged from storages less than 10 sq ft to a fill area of almost 100,000 sq ft.
